Corrosion Evolution Interface studies of CO₂ Exposed Steelinfused Cement Sample using Micro-Computed Tomography

Soumya Pallipotta (1)*, Anna Magdalena Stroisz (2), Dag Werner Breiby(1), Pierre Cerasi (2), Basab Chattopadhyay (1)

¹Department of Physics, Norwegian University of Science and Technology (NTNU), Trondheim, Norway, ²SINTEF, Trondheim, Norway.

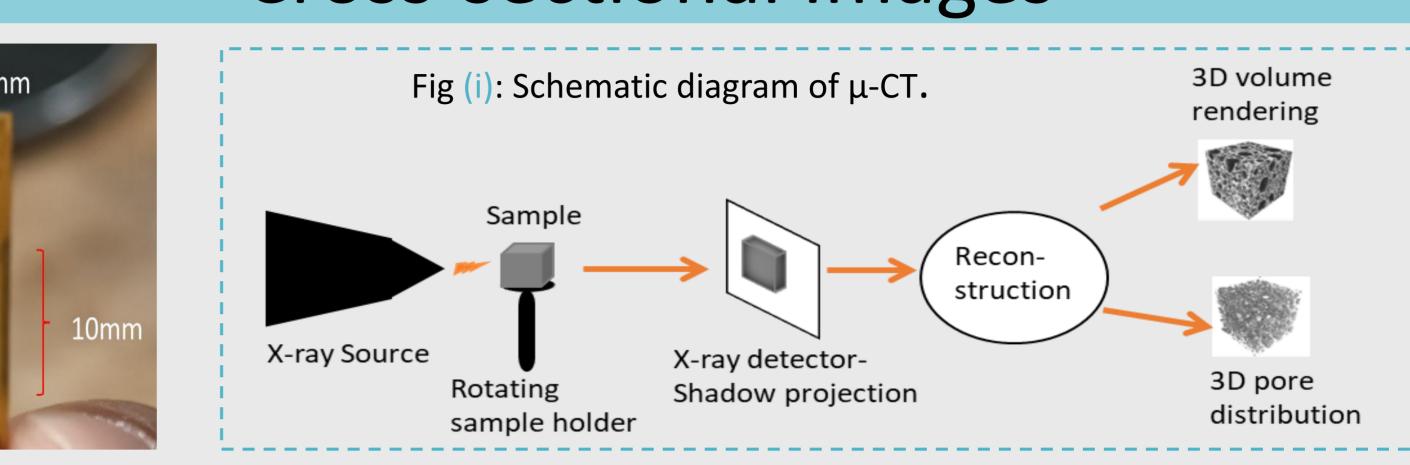
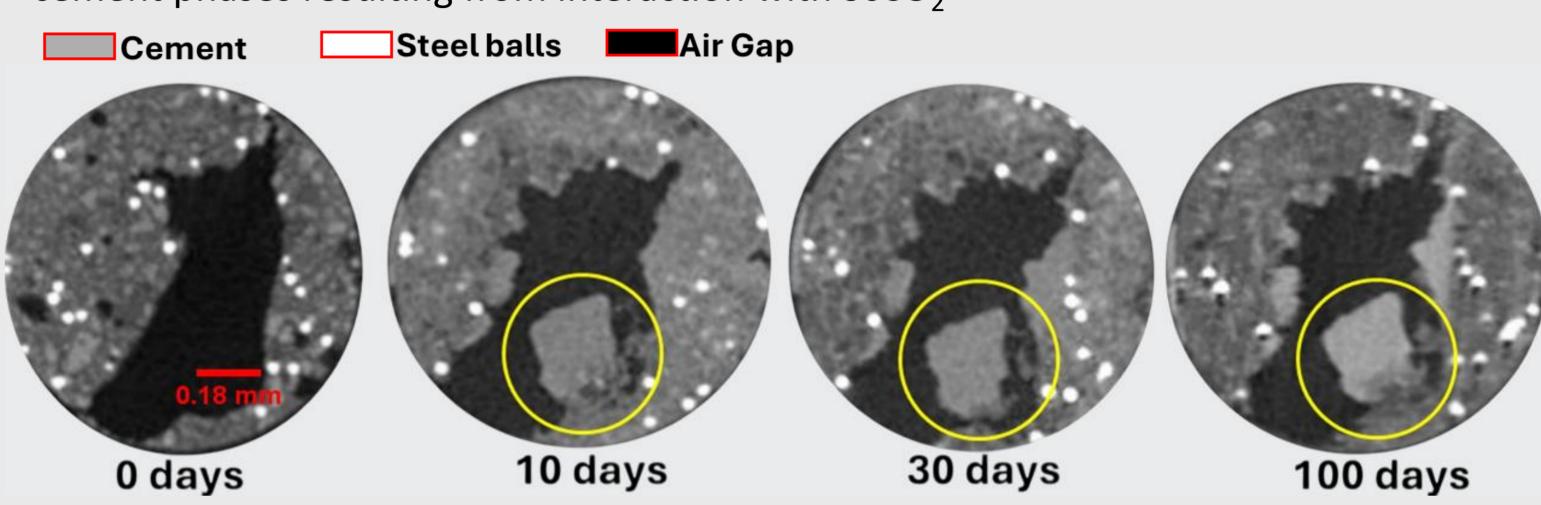
Reaction front in a steel (27-30 µm) infused cement sample of diameter 1mm after exposure to CO₂ up to 100days. Yellow circles indicate regions of degraded/carbonated cement phases resulting from interaction with ScCO₂

- μCT analysis of the steel-infused cement revealed progressive phase degradation and carbonation from CO₂ exposure, with SEM and XRD providing complementary insights into morphological changes and hydration compounds.
- As part of future work, an electrochemical cell will be developed to evaluate corrosion rates. Fig (vii), gives the rough sketch of the cell, which will be connected to a Potentiostat and integrated with the CT system for in-situ analysis. (The design might be modified based on the requirements)

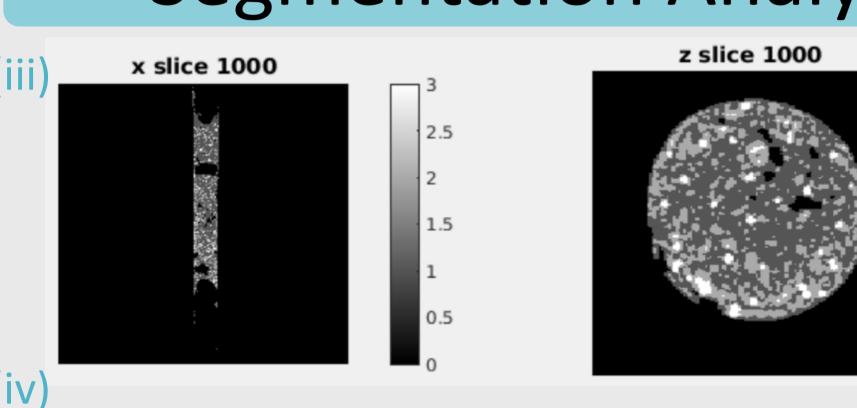
IV)			
Exposure Time/Days	Cement (%)	Aggregates (%)	Steel balls (%)
0	47	49	4
10	46	50	4
30	38	58	4
100	33	63	4

Fig (iii): Vertical and horizontal cross-sectional segmented images of the sample, (iv): Tabulated volumetric analysis of the different phases present within the sample.

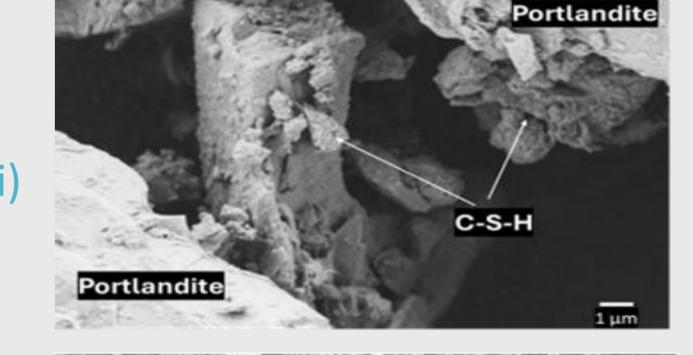
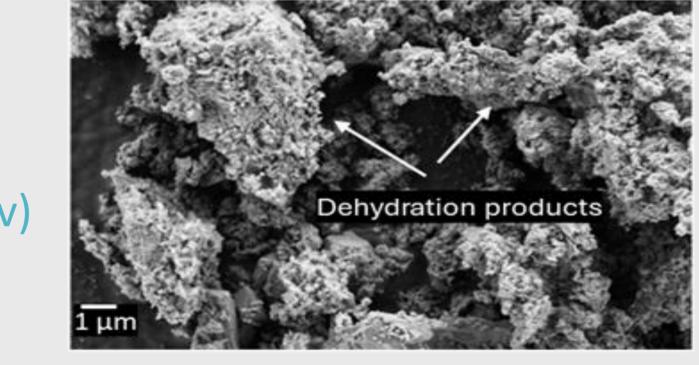
The scanning electron microscopy images reveals that C-S-H phases in (v) unexposed Portland cement powder and, (vi) CO₂ exposed steel infused cement dehydrated under high temperatures, forming a flocculent structure.

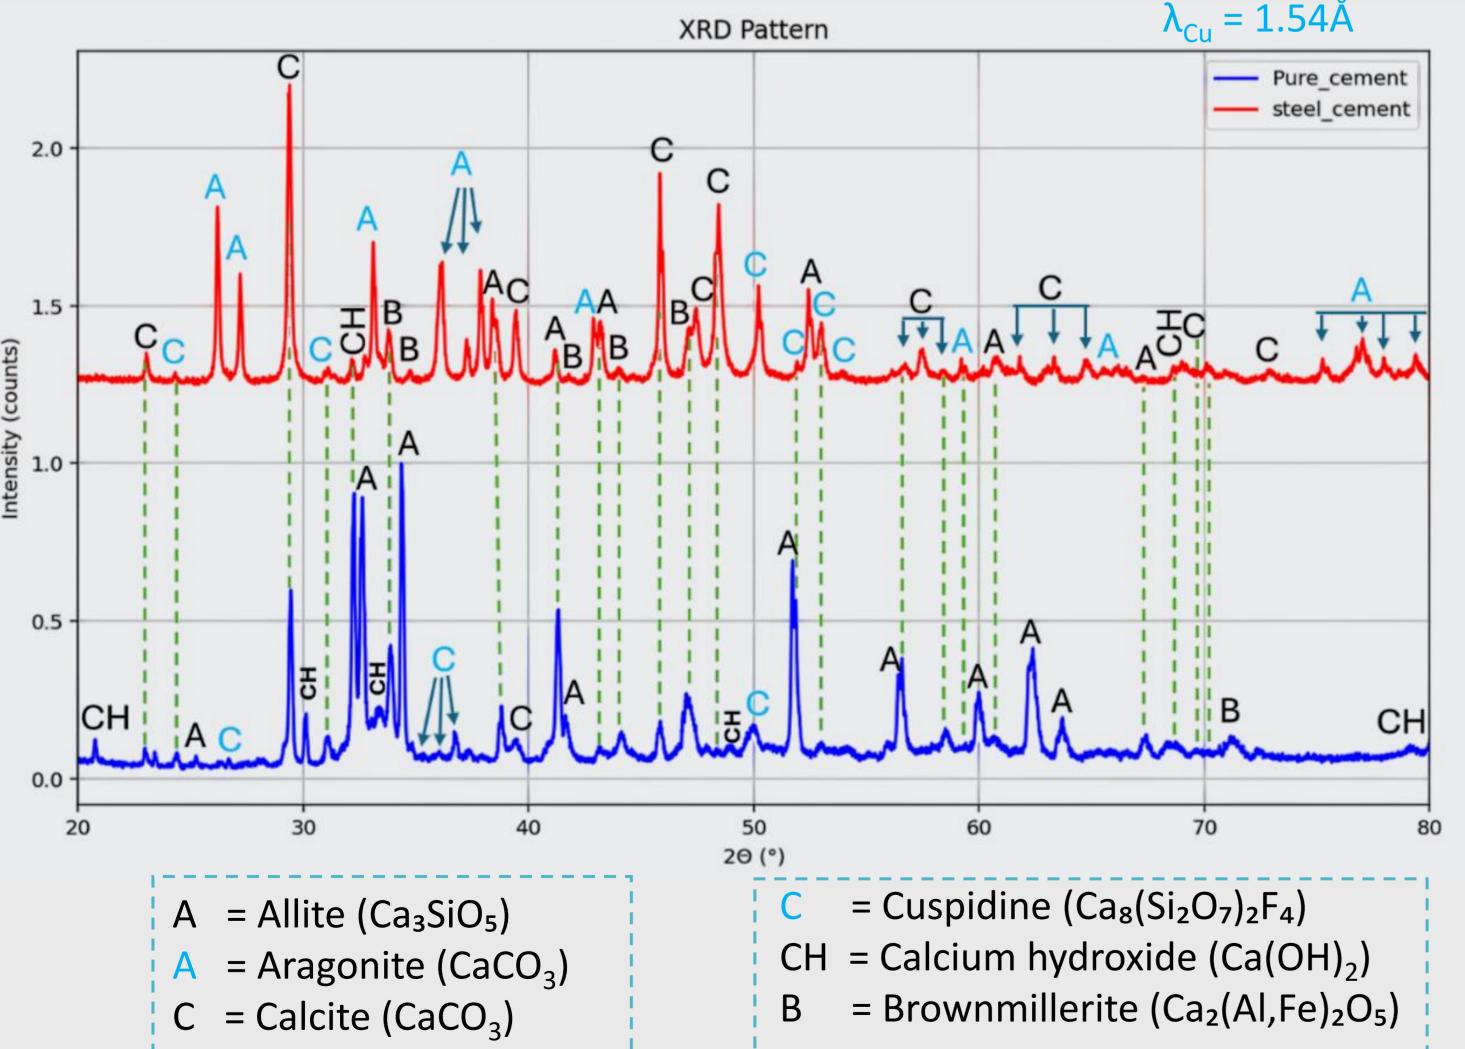
The above graph illustrates the X-ray diffraction peaks of unexposed Portland cement powder and CO₂ exposed steel infused cement sample.

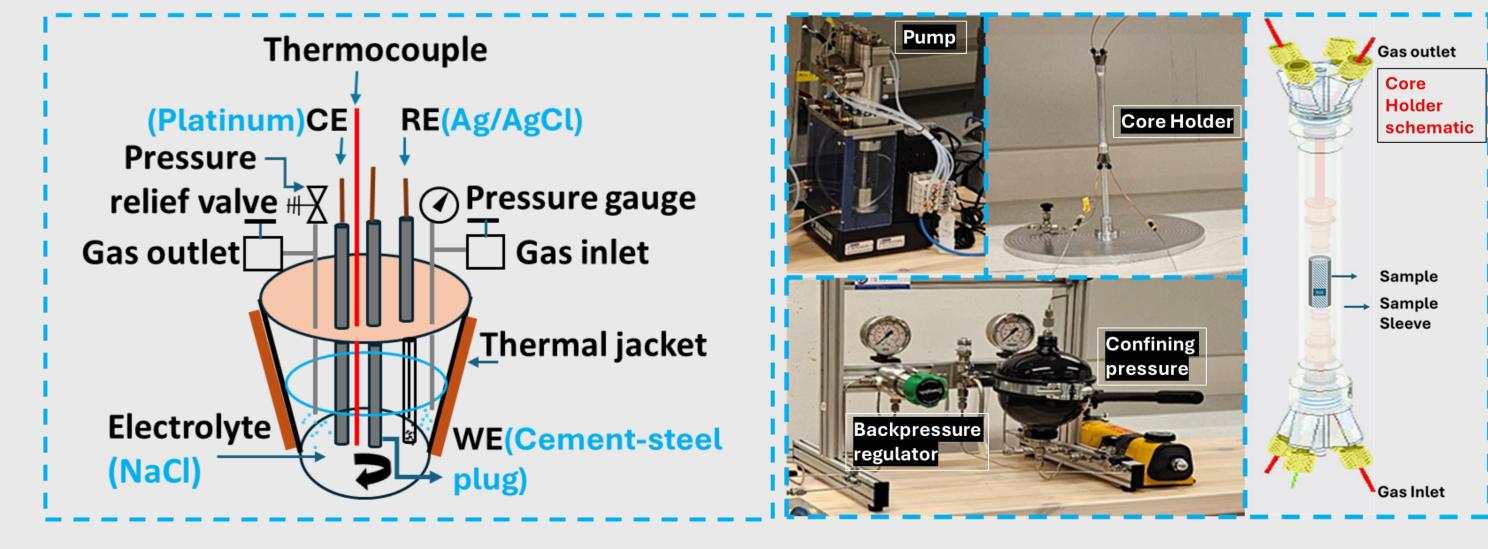
Fig (Vii): Electrochemical cell with three Fig (Viii): shows the home laboratory electrodes, CO₂ inlets/outlets and core flooding setup for precipitation temperature/pressure control systems.

studies.
